SW Cor. NE-SE Sec. 36-76-19

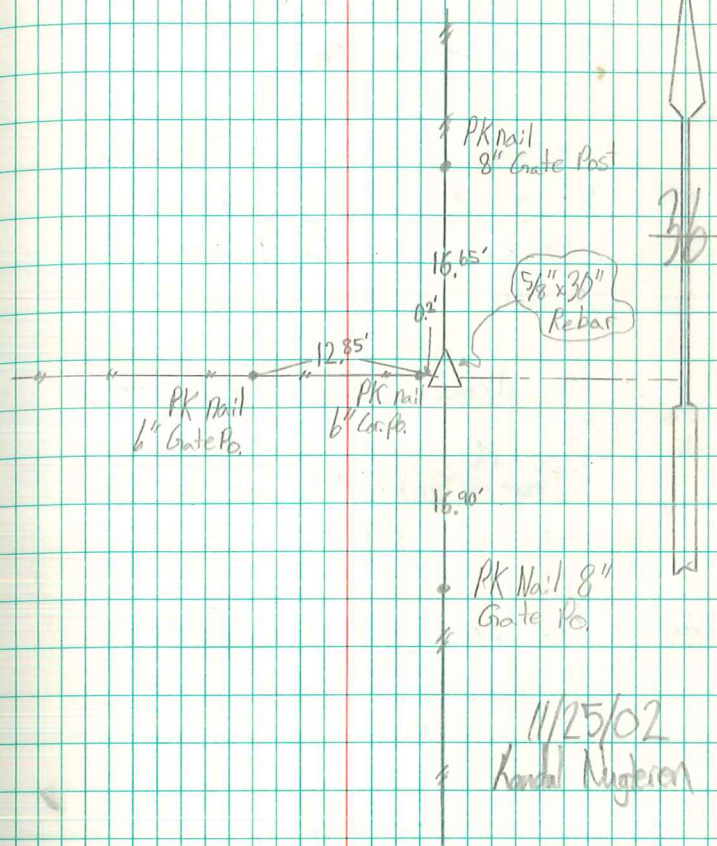
11/7/02 - Fnd 5"x8"x12" painted Yellow Limestone
on E. side of cor. post. at old
Fence corner.

Also fnd 6"x7"x19" Rectangular
Sandstone lying flat directly E.
of painted Limestone.

It appears to have fallen from
a position directly above the
limestone due to some erosion
at the corner.

Lowered painted Limestone 4" deep.

Set 5/8"x30" Rebar on E. side
of painted Limestone
