N.E. Cor. Sec 34-76-19

Set: May-7-1941

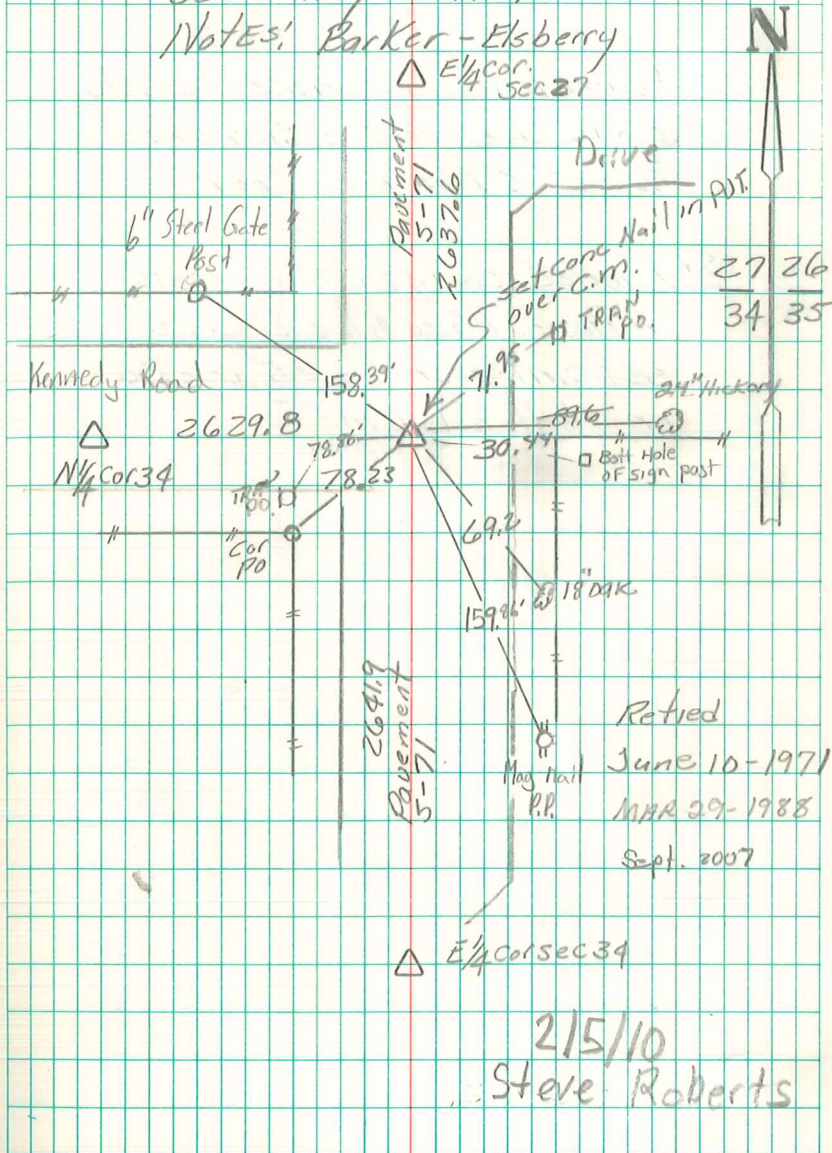
Watkins Witness Corner S.E. Destroyed
by erosion, Wit. Corner N.W. either
under deep Fill or Destroyed by
Culvert Construction. True Corner
under 10 Foot of Road Fill.

After Searching For witness Corner
& Finding No evidence, I re-established
this corner on line from 2 Gout
corners North at double the $\frac{1}{4}$ mi.
Distances, which is on line with
stones East, and 4' North of E. East.

set C.M. 12" Below Surface, over 12" tile
